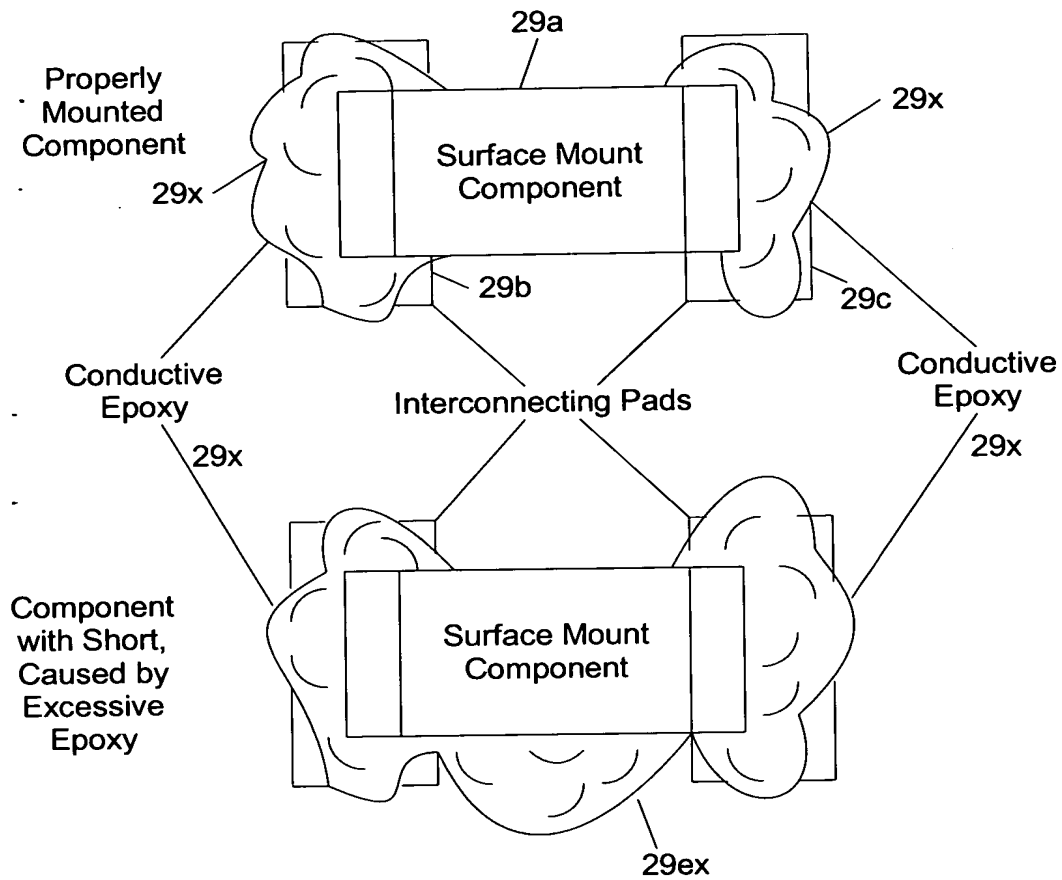
Fig. 2A

Multichip Ceramic Package 28

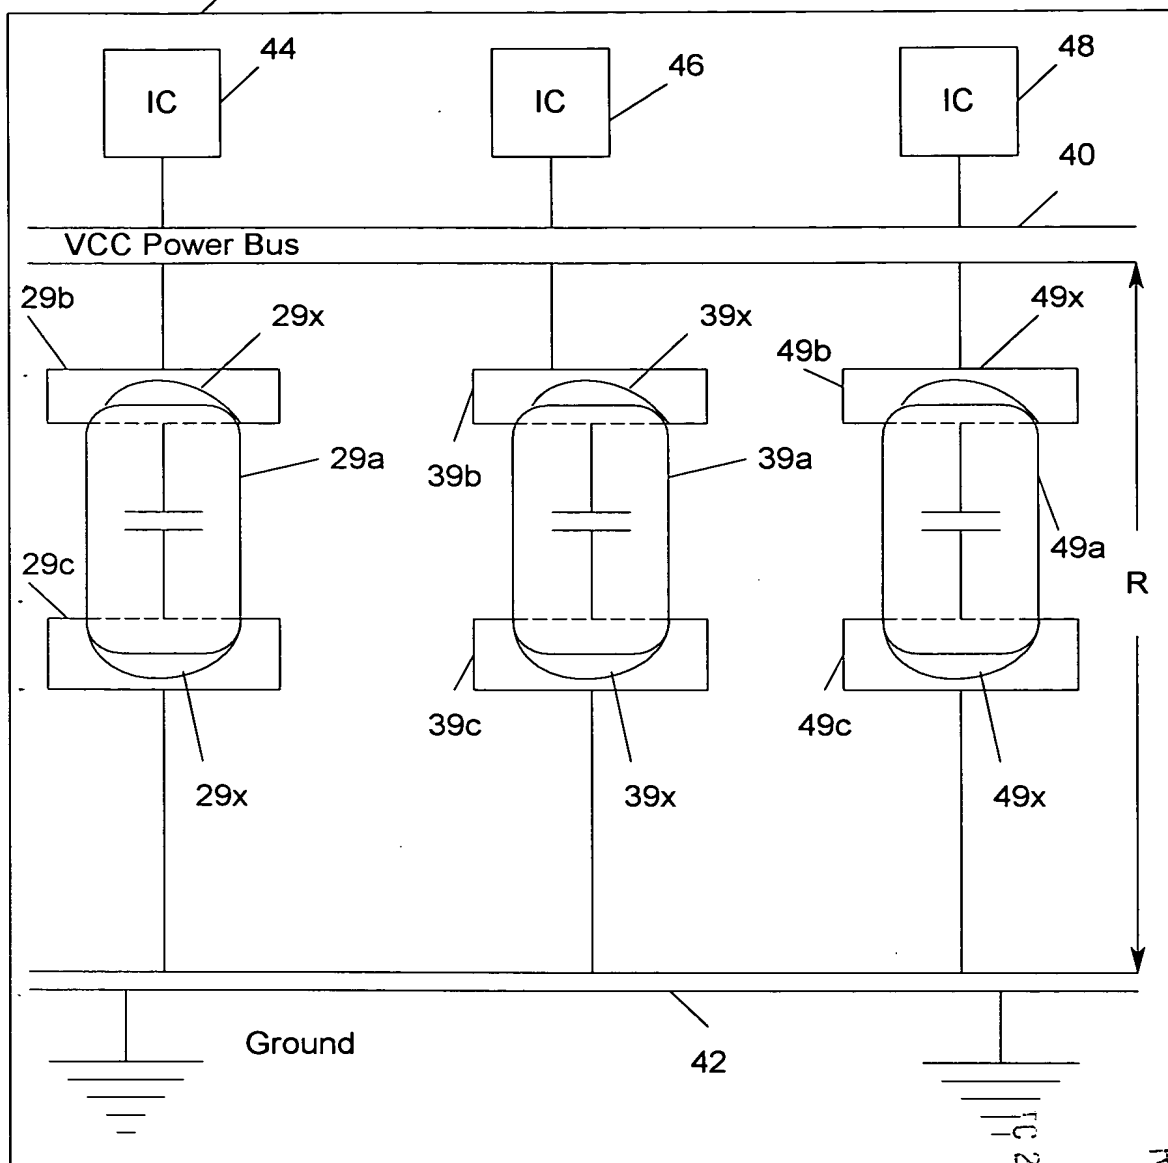
Fig. 2B

R =
measured
resistance
during temperature
ramp-up and ramp-down

Defective Part with Intermittent Short (W1008)
